The Development and Testing of a Full-Scale Piloted Ornithopter

J.D. DeLaurier *

ABSTRACT

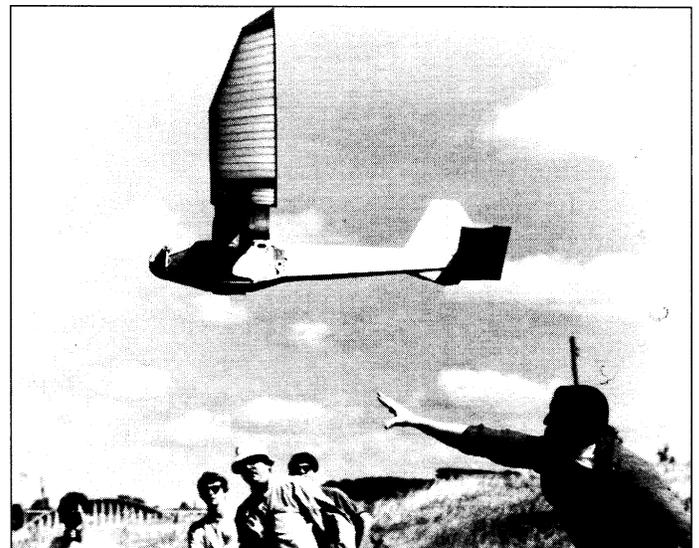
Figure 1.
Proof-of-concept model ornithopter being launched.

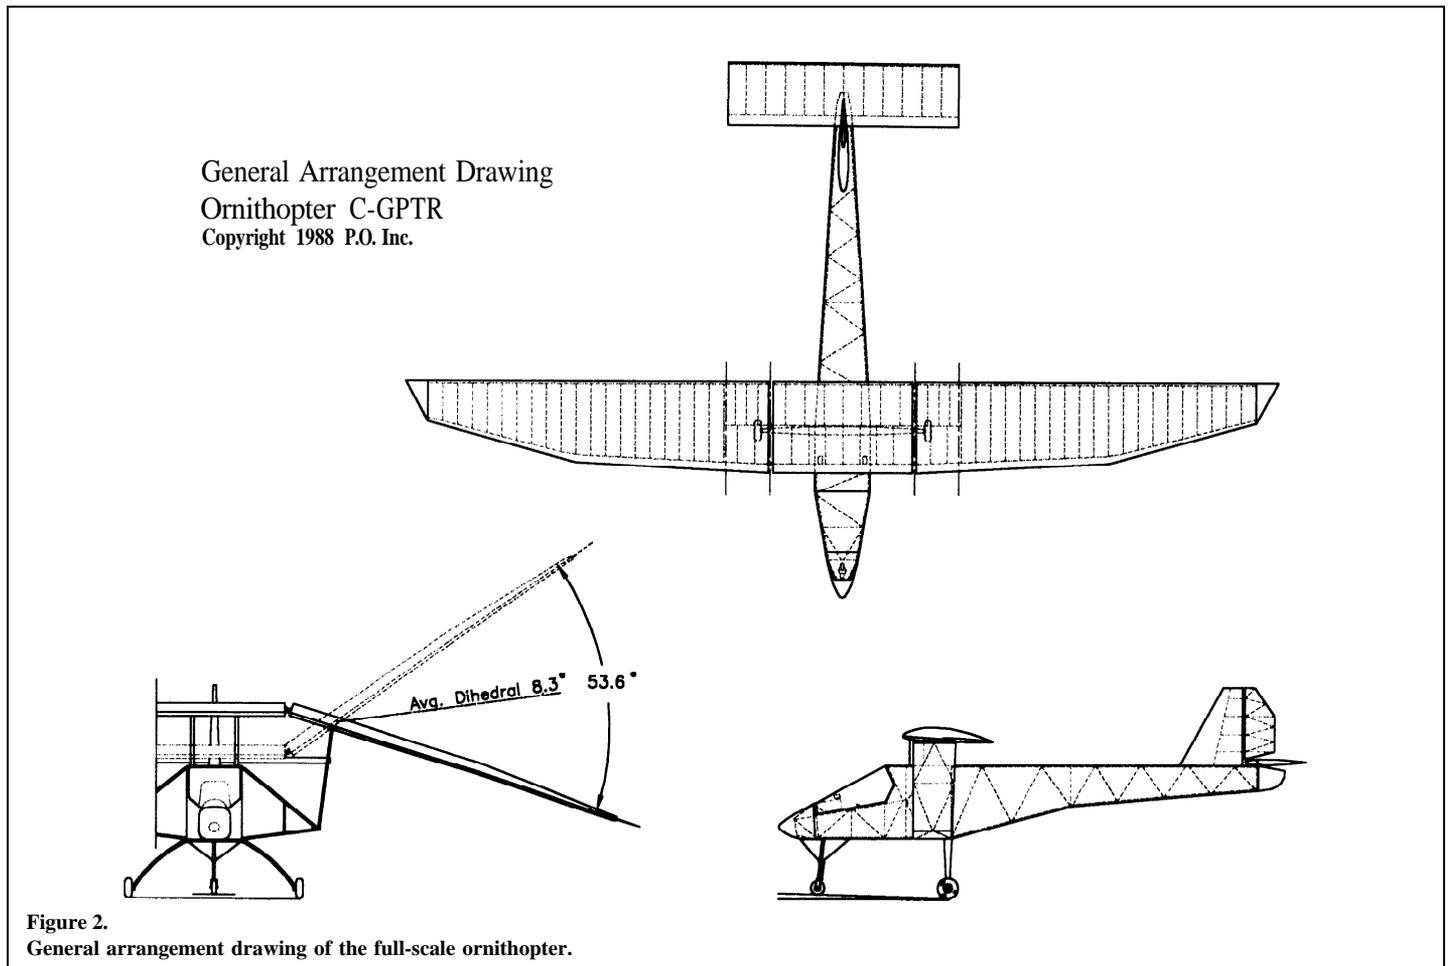
A general arrangement drawing of the ornithopter is shown in **Figure 2** and photographs of the uncovered and covered craft are shown in **Figures 3** and **4**. The design process began with the goal of building a single-seater aircraft powered by a 24-hp König engine, popularly used for ultralight aircraft. It was felt that by choosing such an engine an “ultralight philosophy” would prevail, resulting in an aircraft of sufficient simplicity and compactness to be achievable with a small team and a limited budget. At the same time, it was desired that the structure should meet Chapter 549 load criteria which requires the ability to experience 3.8 g before failure occurs. The consideration was that if the ornithopter had commercialization potential, it should have the operational robustness of a general-aviation airplane. As will be described, these goals were successfully achieved with an aircraft that is approximately four times bigger (in linear dimension) and 76 times heavier than the proof-of-concept model. In particular, its overall as-built characteristics are:

The required cross-section for the thorax gave more than sufficient cockpit cross-sectional area for the pilot. Therefore, what remained was to shape an enclosure that provided sufficient pilot leg room as well as structural accommodation for a forward undercarriage element (nose gear). Also, it was desired to incorporate a windscreen (canopy) shape consisting of a simple transverse curve. A wind-tunnel study was performed which showed that if the fore-and-aft slope of the canopy is blended to the rest of the cockpit and the following thorax (as shown in Figure 2), the fore-body drag is very acceptably low.

As mentioned before, the ornithopter is powered with a König 3-cylinder, 2-cycle, radial engine that produces 24 hp at 4000 rpm. The drive-reduction unit, shown in **Figure 7**, was designed to efficiently transmit this power to the wings in order to flap at a maximum frequency of 1.2 Hz. Its drive ratio of 60 to 1 is achieved with a three-stage reduction using chains and sprockets, terminating in a Scotch-yoke mechanism to convert the rotary motion to oscillatory motion driving the vertical pylons upon which the centre panel is mounted (**Figure 2**).

As seen in **Figure 2**, the wing has an average positive dihedral angle because its maximum upstroke angle is larger than its downstroke angle. In fact, this effective dihedral is more than the arithmetic mean if one does a time averaging of the dihedral angles through the flapping cycle. From the excellent turning performance of the proof-of-concept model, it was clear that yaw-roll coupling works well as a means for directional control.

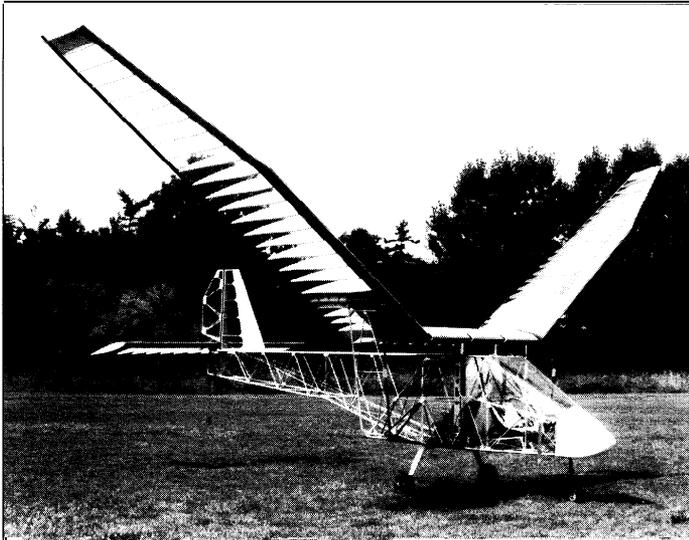
Figure 3.
Full-scale ornithopter before covering.

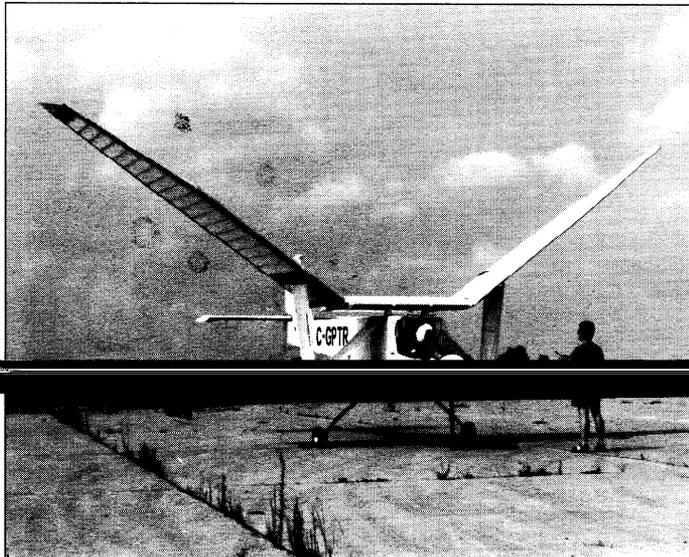
Figure 4.
Completed full-scale ornithopter, 1997.

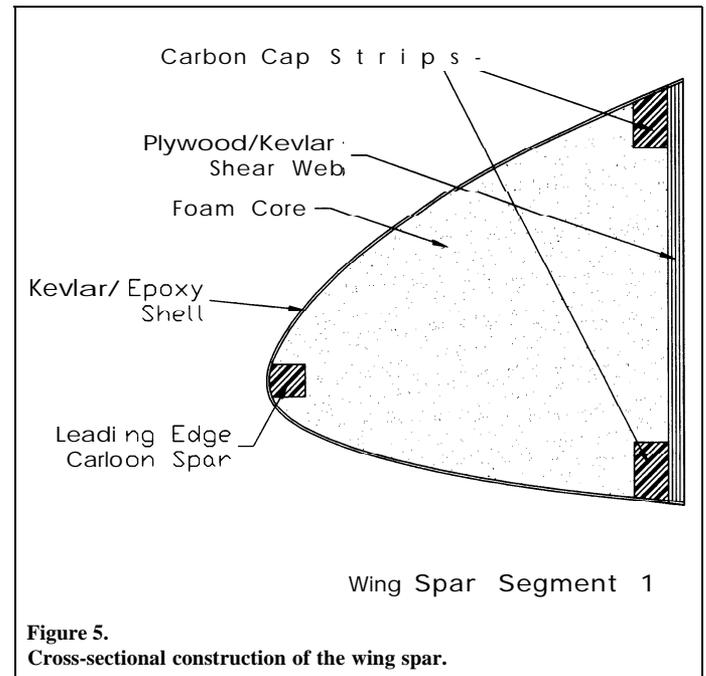
The spar construction is shown in Figure 5, consisting of a “wet lay-up” of Kevlar cloth and epoxy over a leading-edge shaped structural-foam core backed with a carbon-fibre reinforced shear web. The ribs are cut from 1/2-inch wide sheets of structural foam and capped with basswood strips. These are glued to the shear web; and the trailing edges are unidirectional carbon-fibre strips. The finished wing, before covering, is shown in Figure 6.

Figure 5.
Cross-sectional construction of the wing spar.

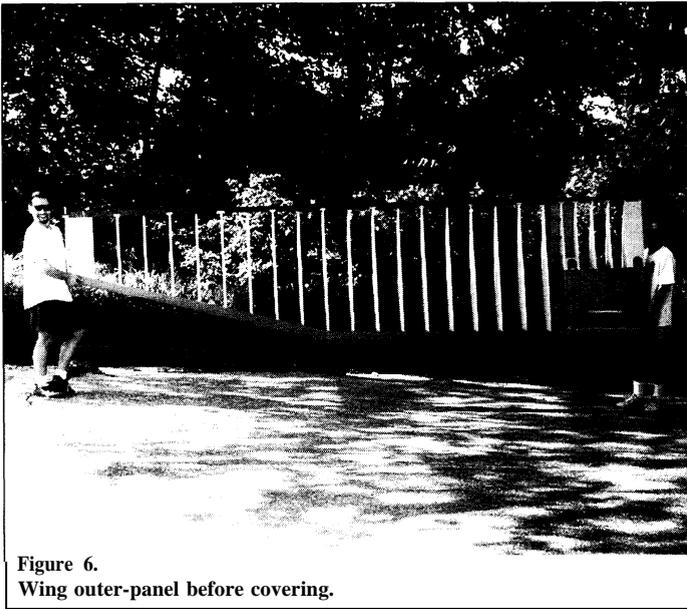
Figure 6.
Wing outer-panel before covering.

As seen in **Figure 6**, the structure of the wing outer panels is open between the ribs until the very last portion near the tip, which was covered (top and bottom) by 1/32" plywood full-chord sheets. These provided a spanwise-rigid surface upon which the tensioned fabric is anchored and also served the purpose of allowing the shearflexing action to carry through. That is, the trailing edges of the sheets are not constrained, relative to one another, in the spanwise direction.

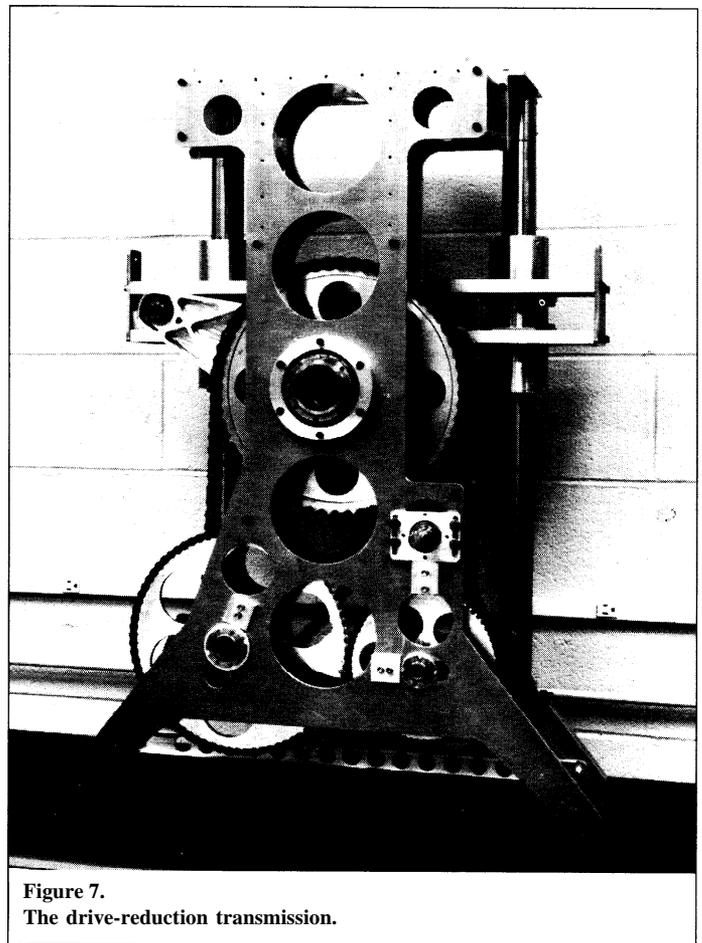
Figure 7.
The drive-reduction transmission.

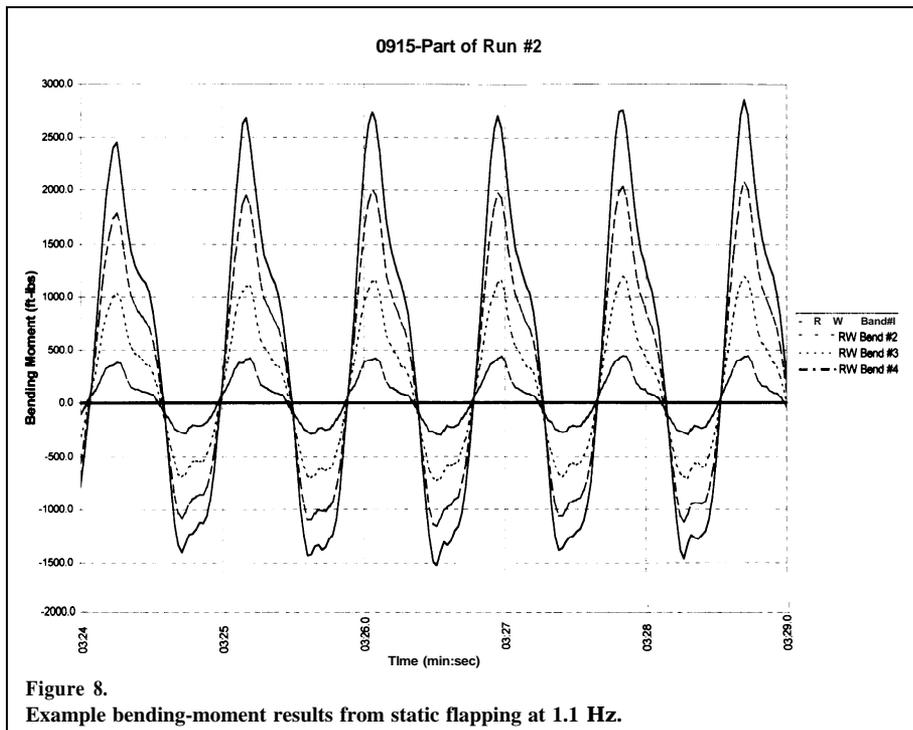
The methodologies for acquiring bending and twisting-moment data are discussed, in detail, in Reference 8; and an example plot (from a 1997 test) is shown in **Figure 8**. The acquisition of this data was important for every test throughout the program, both static and taxiing. The reduction of the most recent readings is now the subject of a forthcoming M.A.Sc. thesis, from which it will be possible to compare the experimental loads with those predicted from analysis.

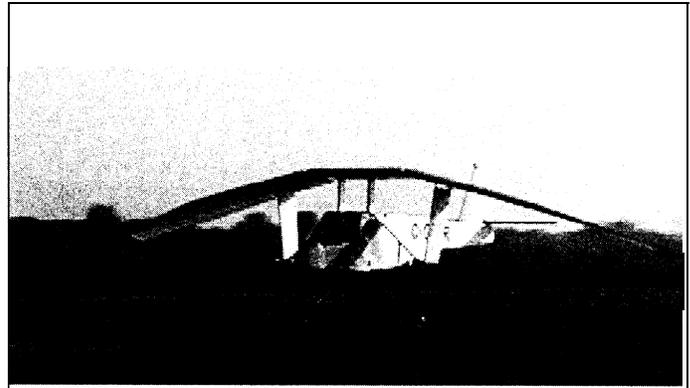
After some additional minor repairs, as well as increasing the nose-gear tire pressure, the aircraft returned to the runway on 15 Sept. The intention of these tests was to explore the effect of applying a certain amount of negative stabilator angle (trailing-edge up) so as to lighten the load on the nose wheel. On this occasion, the aircraft accelerated to a speed of approximately 40-mph and the applied stabilator caused a series of controlled bounces of increasing amplitude until the pilot throttled back. This was not sustained flight because the aircraft only rose during the downstroke of the wing and would touch down during the upstroke (**Figure 9**).

Figure 9.
15 September 1997 taxi trial.
